Medical Devices Safety Update

Volume 4, Number 1, January 2016

Battery management a growing issue

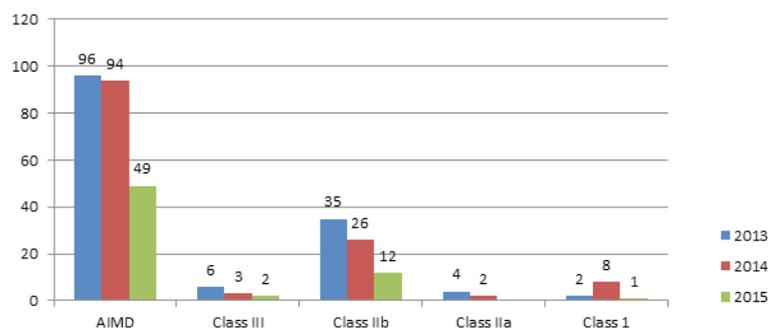
Figure 1: All battery-related reports Jan 2013 – Oct 2015 by device category

In total there were 345 battery-related reports from January 2013 to October 2015, with AIMDs dominating the battery failure reports. The batteries on these devices are generally non-rechargeable and replacement would require surgery.

Investigations usually reveal battery depletion is due to excess current drain (low circuit impedances, high output settings and the like) and not generally battery failure.

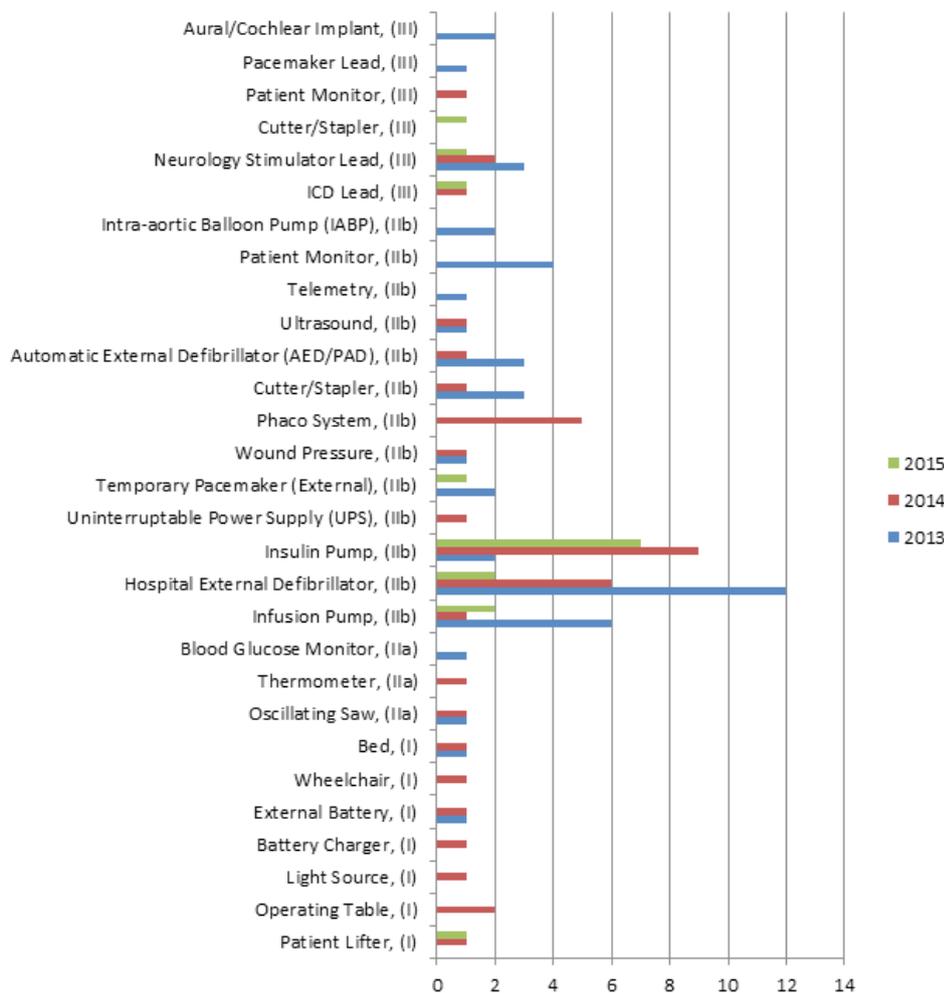
Figure 2: All battery-related device problem reports January 2013 – October 2015 (excluding AIMDs)

In addition to battery problems with AIMDs, there have been reports for other devices such as infusion pumps, insulin pumps, patient monitors and vision systems. A wide variety of devices and battery types are represented (see Figure 2).

The most common kinds of battery failures are for rechargeable batteries that fail to charge, fail to hold a charge, or are not inserted correctly.

Health facilities and those responsible for maintenance of devices containing batteries should ensure that suitable protocols and procedures are developed to optimise battery management and reduce risks. Factors that these protocols should consider include:

- ensuring staff are familiar with and follow the manufacturer’s instructions
- using the best quality battery cells available
- developing a planned replacement schedule
- routine retirement of old batteries
- ensuring charging regimes suit each battery type
- setting up routine battery testing timetables
- incorporating recycling options.
